SECTION 13900
CURING AND DISINFECTING

APPENDIX D
TANK INSPECTION REPORTS

Condition Assessment

May 2, 2023
Full condition assessment
Visual
North
Nick Rapagnani
1-973-462-7381
nick.rapagnani@usgwater.com

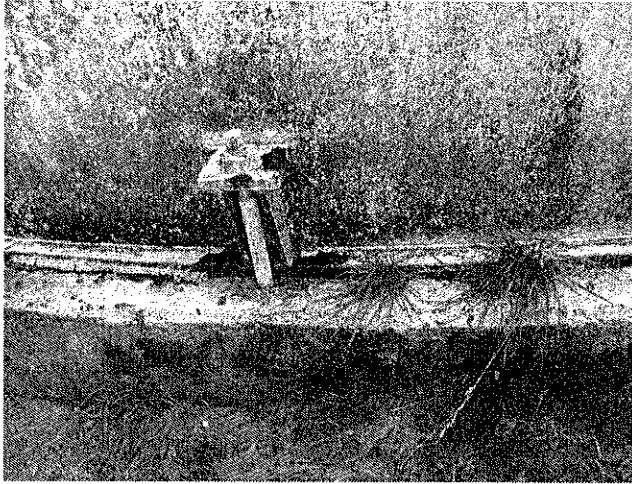
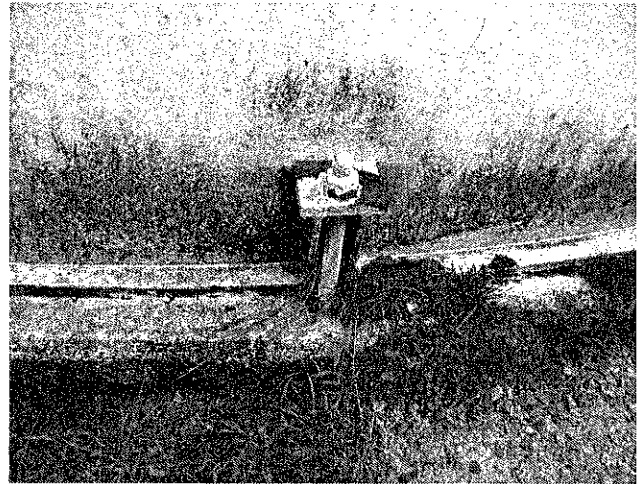
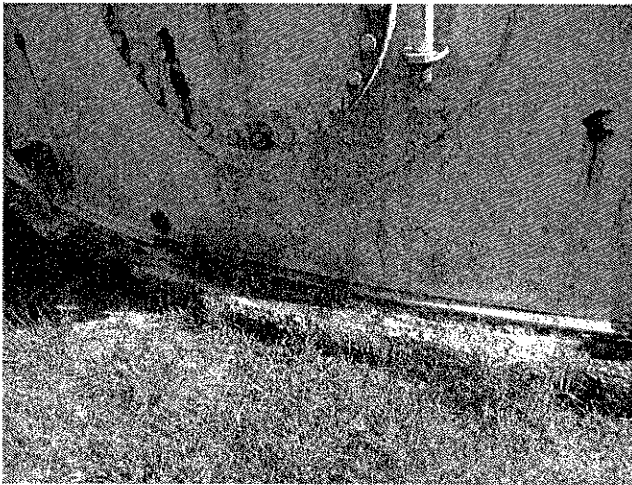
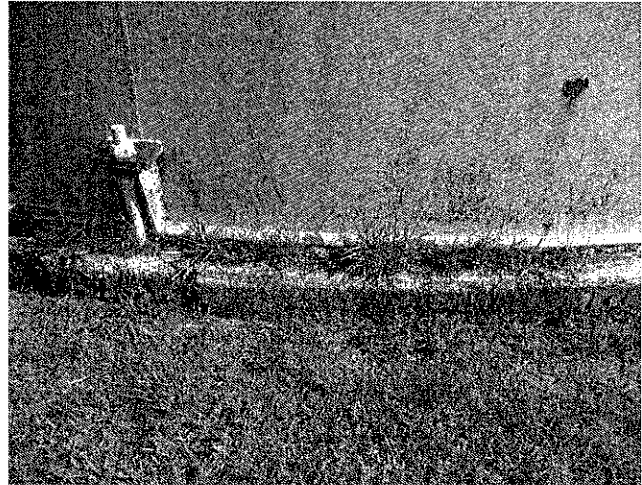
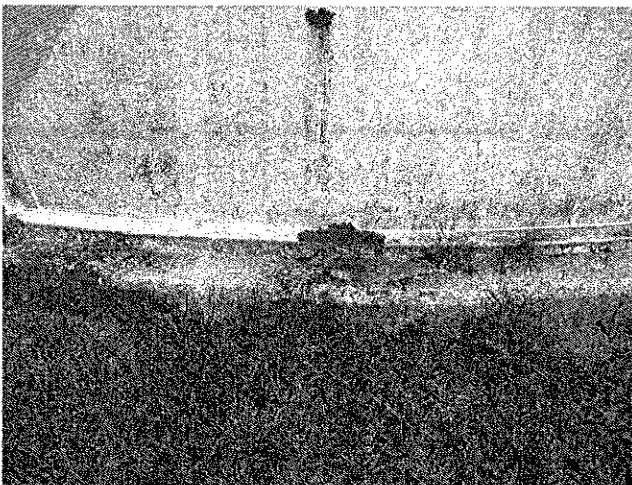
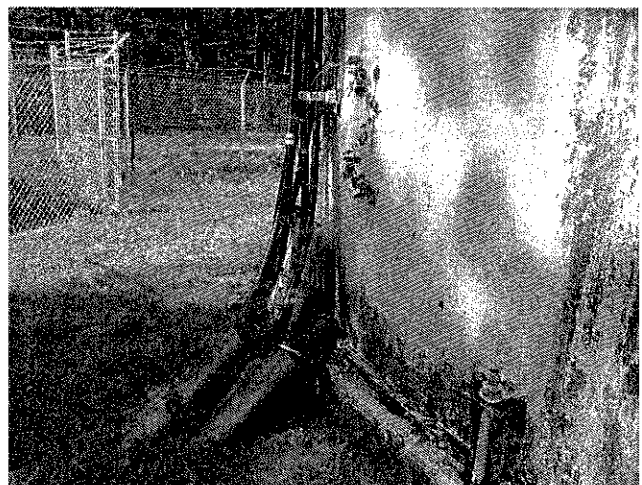
Foundation and Anchor Bolts

2.	The perimeter fence has been damaged and needs to have the barbed wire tightened across the top.
3.	The foundation should be pressure washed the remove weeds and dirt, and then the base should be resealed to prevent water damage under the tank.

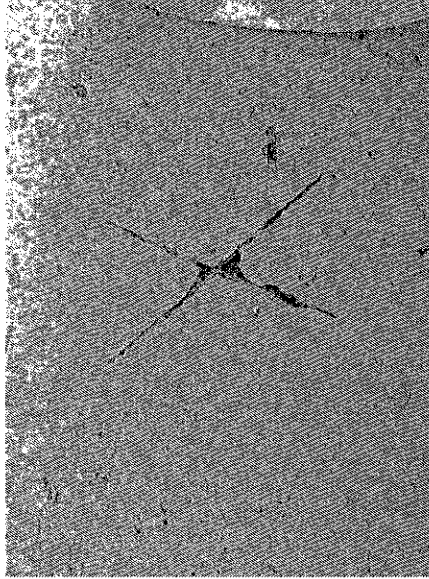
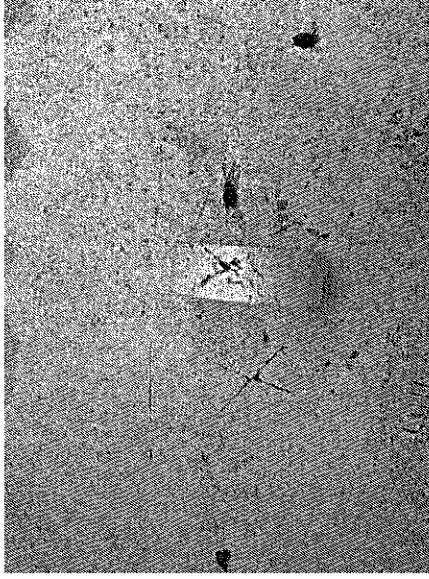
Dome
 Steel
 0
 11.5

1a - Most of area removed along X under tape
 Adhesion Failure - Multiple Coats above and below Failure
 Fading or Chalking Present
 Cracking, Blistering, or Peeling Present
 Bio-Growth Present

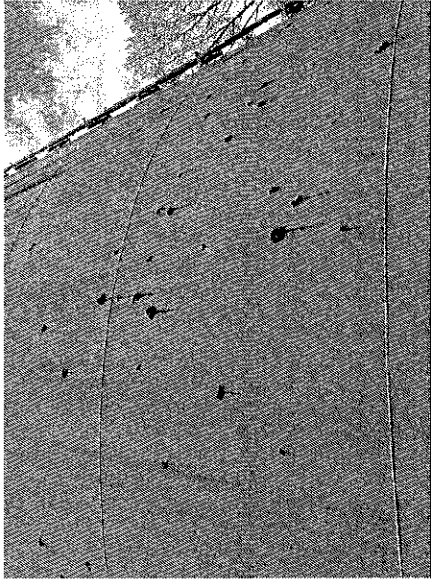
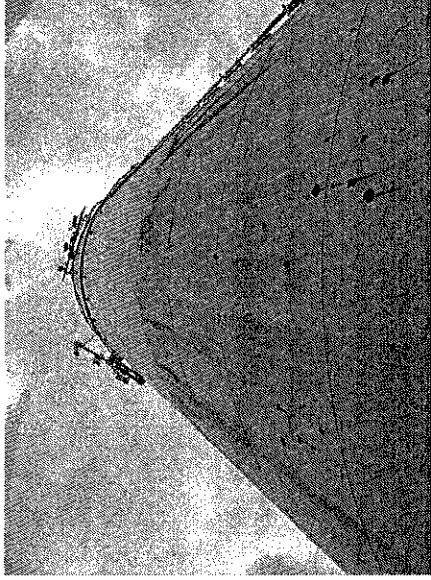
Exterior Shell - Coating failures or issues Photo

Adhesion Failure - Multiple Coats above and below Failure

Fading or Chalking Present

↳ I recommend a full abrasive blast.

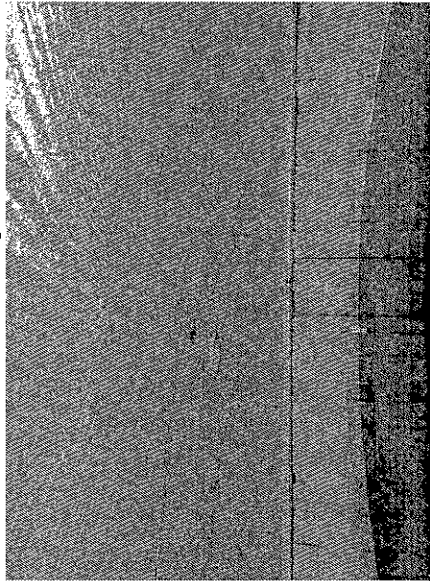
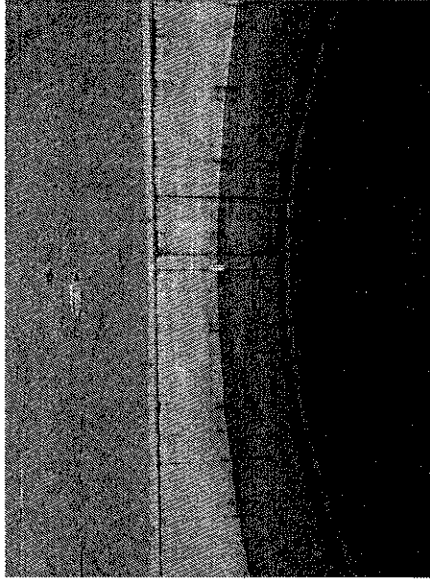
Water Chamber Roof - Coating failures or issues Photo

Flash
20

↳ I recommend a full interior abrasive blast
SP10 Near White Blast
Full Prime
Intermediate Stripe Coat
100% Solids Epoxy Full Interior Finish Coat

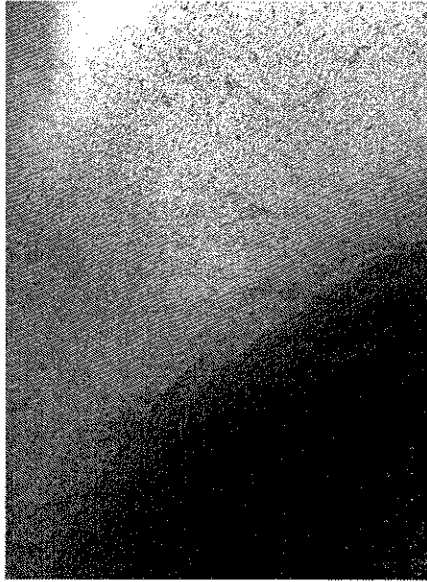
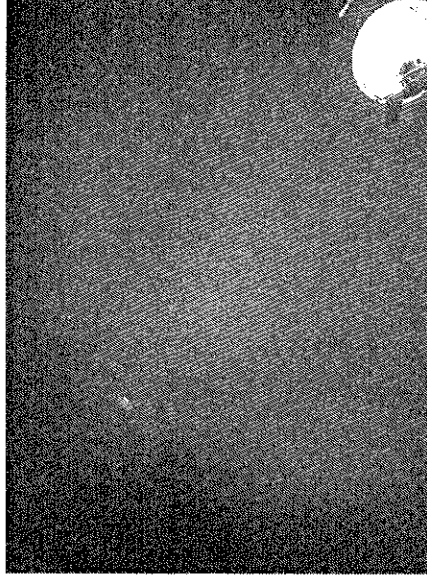
Water Quality Issue Photo

Heavy sediment buildup
Washout cleaning

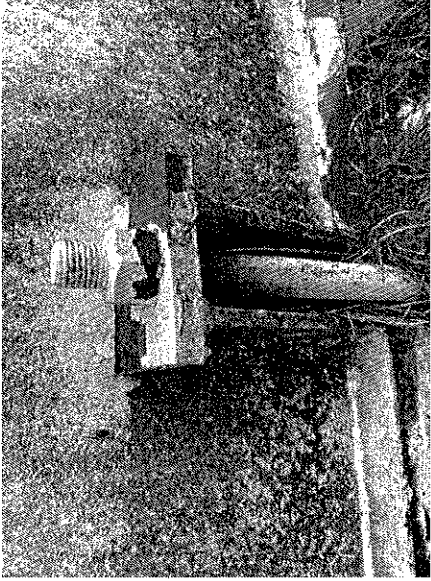
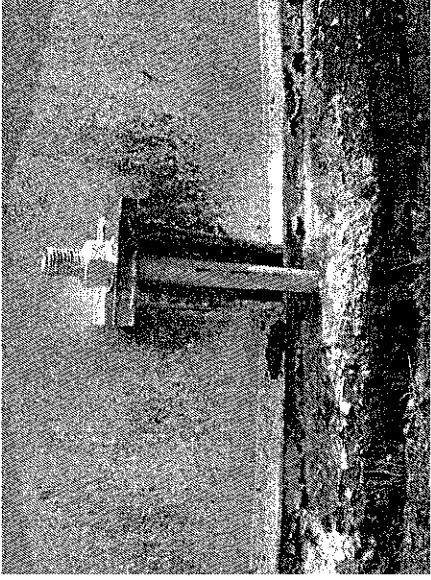
Anchor bolt(s) Photo

No deficiencies visible
1 5/8
No repair/replacement needed

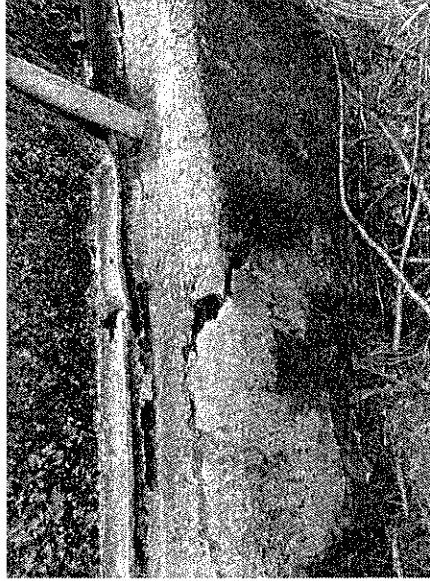
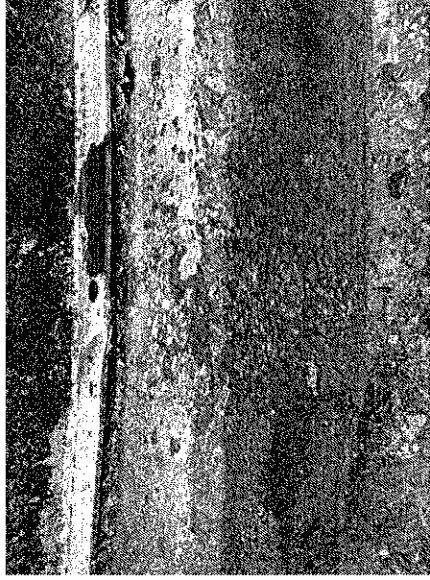
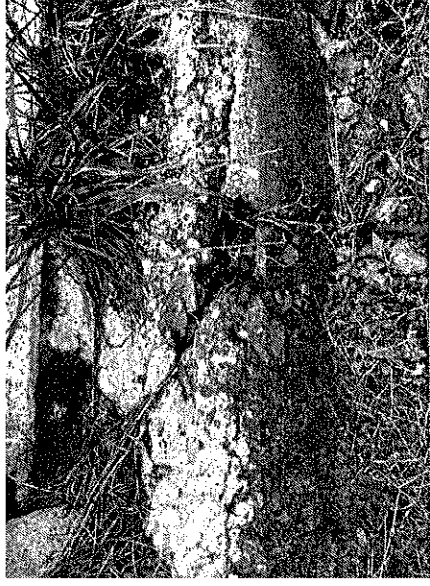
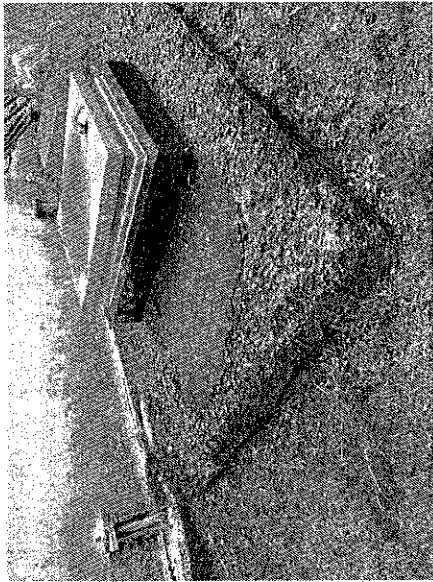
Foundation Photo

Cracks present
Surface erosion
Spalling

Vertical cracking
Horizontal cracking

Water erosion-improper water runoff

↳ Repair cracks and spalling on the tank base. Mortar should be sufficient enough. The concrete around the pit should be formed and concrete should be poured over.

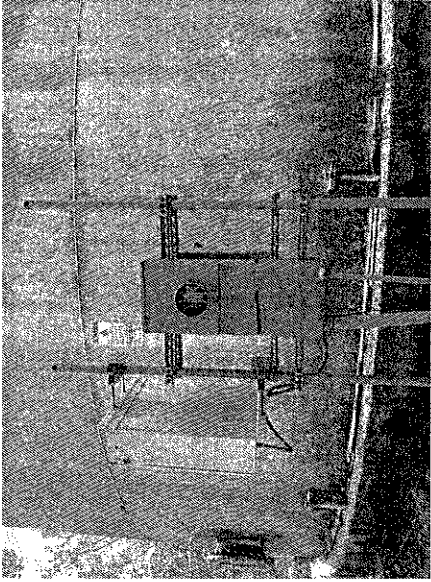
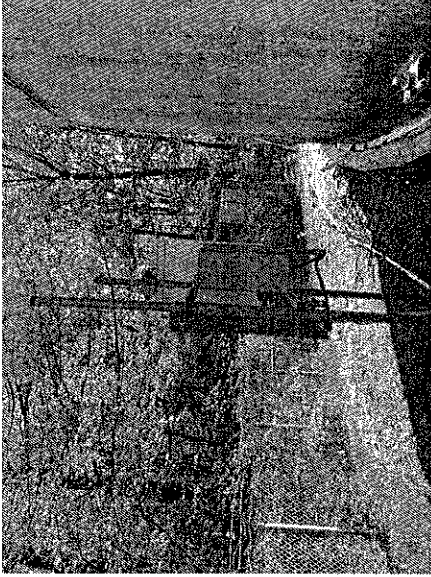
Lighting and Electrical Photo

Around tank base
Power to tank accessories
Post mount
Flexible
Replace
↳ I would advise this electrical system be removed because it seems to be inactive. It is also right below that ladder making it a hazard to climb.

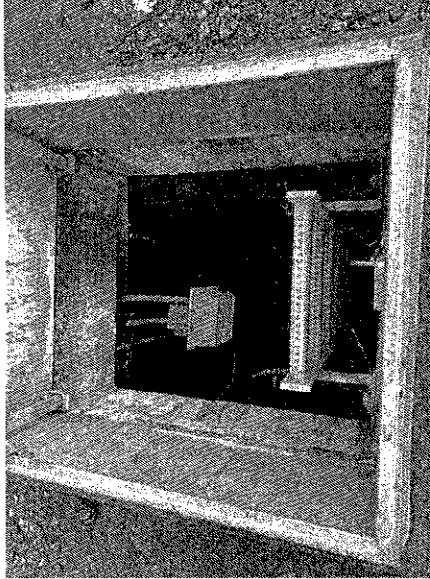
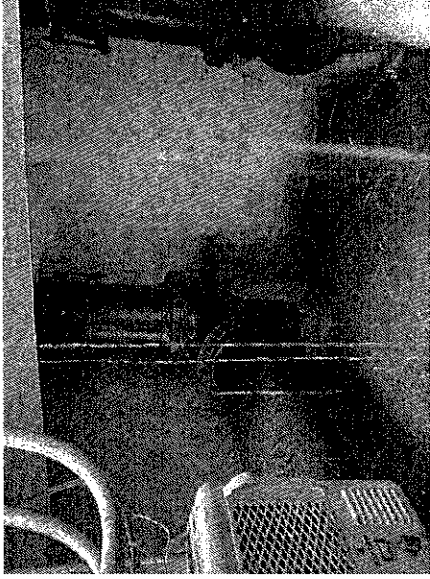
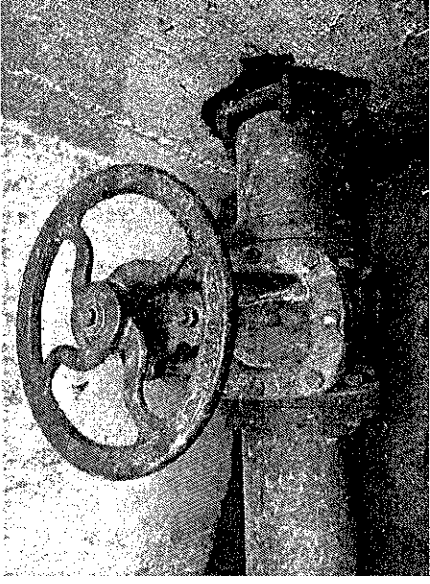
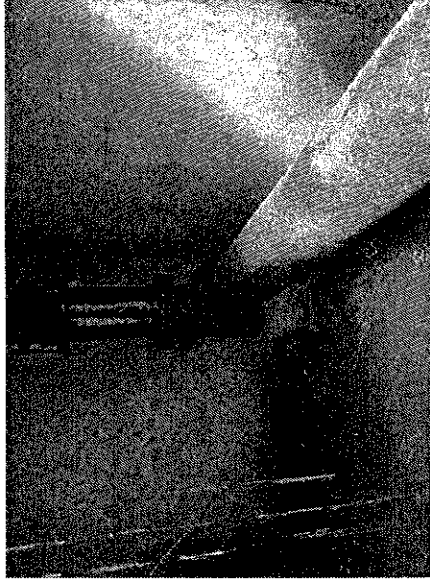
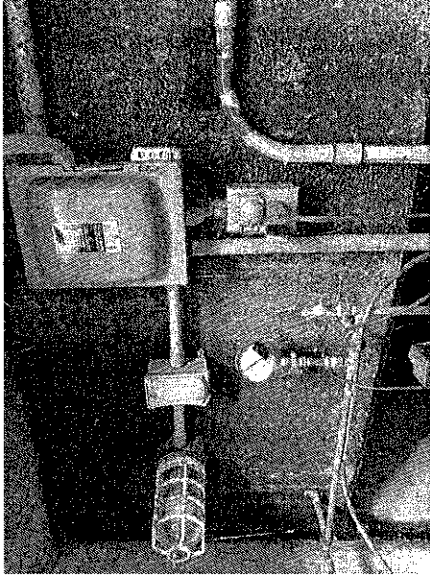
Valve/Pump house Photo

Good
Yes

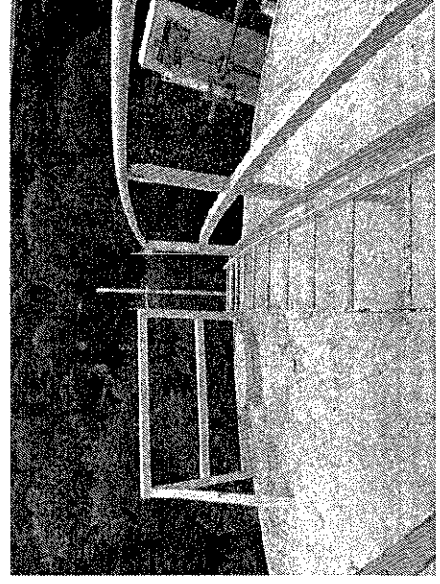
Handrails/Platforms Photo

Exterior roof
 Steel
 Can pass an 18" sphere through handrail at any point
 Install
 ↳ Install a rail between upper and mid rail to close the gap to under 18"

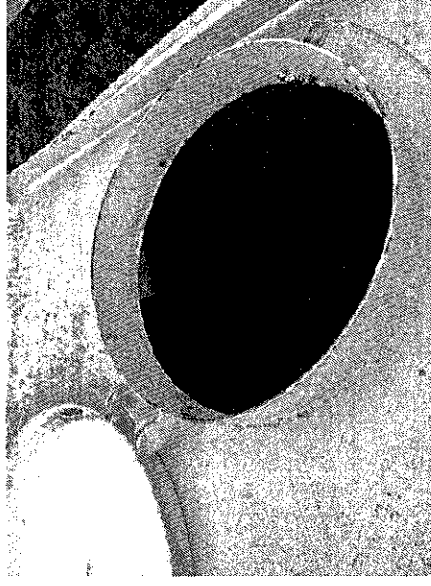
Hatch Photo

Water chamber-roof perimeter
 Round hinged
 24
 Lockable but not locked
 ↳ No
 Unsatisfactory
 ↳ Needs a lock.
 Install
 ↳ Install lock

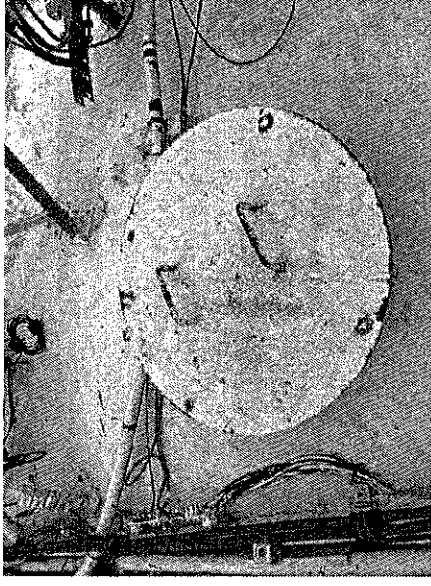
Hatch Photo

Hatch location Water chamber-roof center
Hatch type Round bolt flanged
Hatch opening measurement(s) IN 24
Hatch security Locked
Hatch compliance with sanitary requirements Satisfactory
Hatch repair/replace/install needed No repair or replacement needed

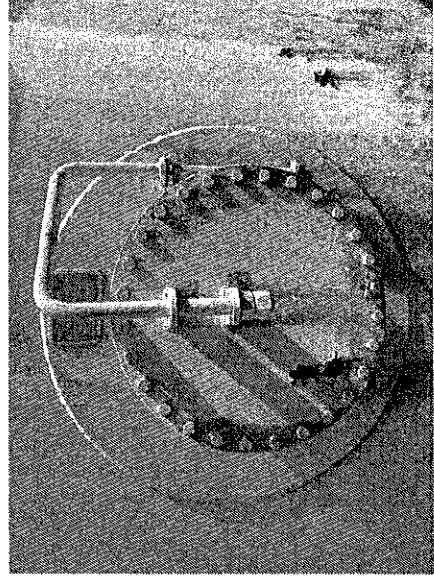
Bolted flange
24
Good
No leaks visible
Good
No repair or replacement needed

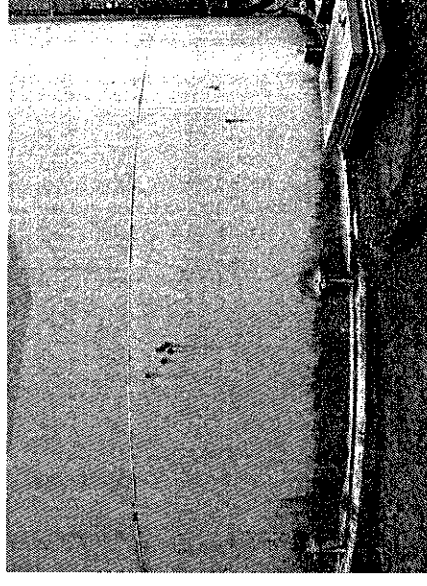
Man way Photo

Shell
Bolted flange
36
Install
↳ Install new 36" man way 180 degrees from current man way.

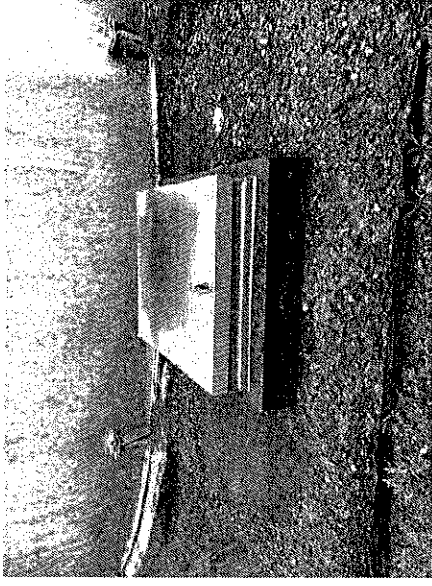
Door/Access Photo

Hatch style man door
Unlocked/not secured
↳ Install a lock.
No repair/replacement needed
