SECTION 13900
CURING AND DISINFECTING

APPENDIX D
TANK INSPECTION REPORTS

Condition Assessment

May 2, 2023
Full condition assessment
Visual
North
Nick Rapagnani
1-973-462-7381
nick.rapagnani@usgwater.com

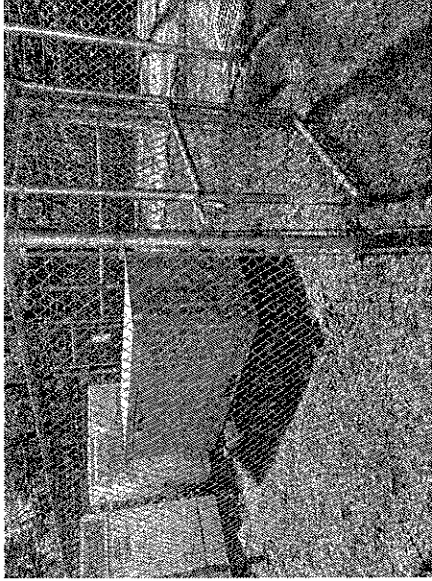
Power lines (3/4 height of tank away)
Cell equipment is within 10ft off the tank

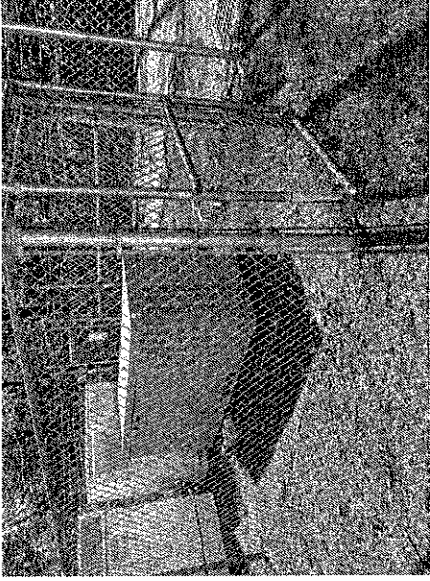
↳ Building in the fenced in area roughly 20ft from the tank.
